UNIVERSITY of KENT at CANTERBURY

**REPORT
on
SUBSIDENCE**

JUNE 1975

HARRIS & SUTHERLAND,
Consulting Civil Engineers,
38-42 Whitfield Street,
London W1P 5RF.

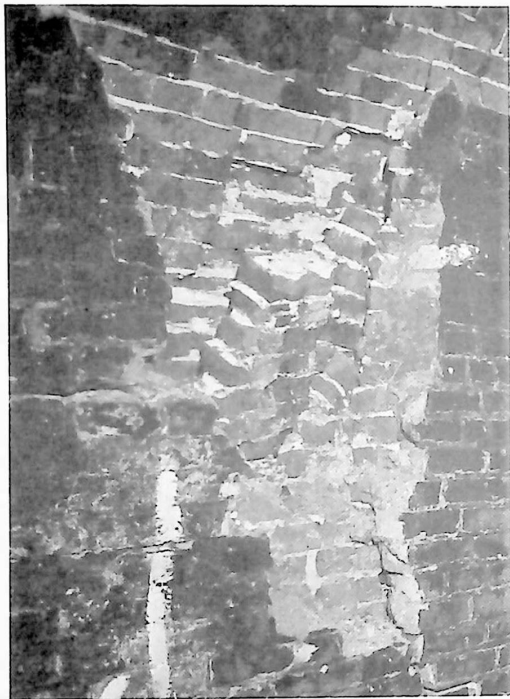
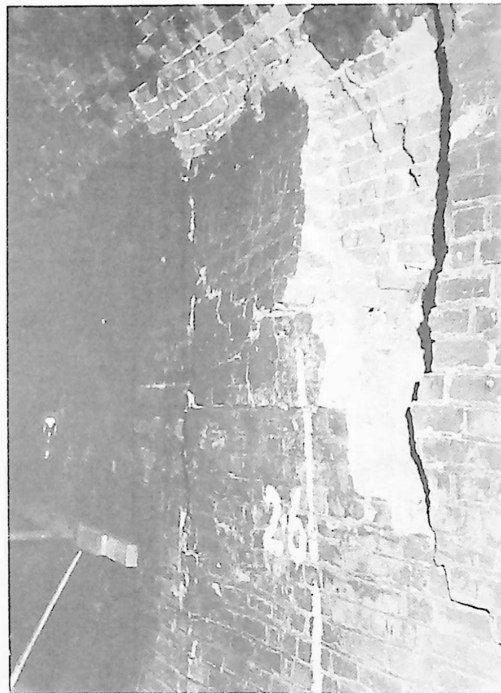
At Ch. 260 brick spalling over about 20 sq.m.

(a) May 1974

(b) Early June 1974

FIG:6. Brick fall on east face at ch 260

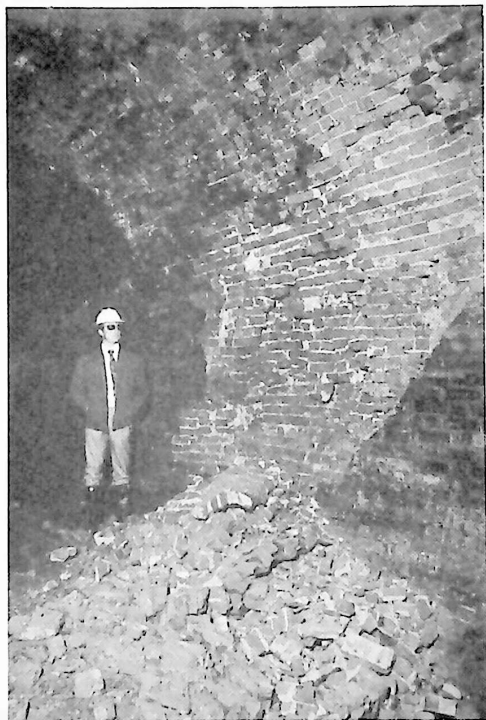
At Ch. 240 brick spalling over about 6 sq.m mainly $\frac{1}{2}$ brick but deeper in places.

FIG: 7. Brick fall on west face at ch.243 — 10 June 1974

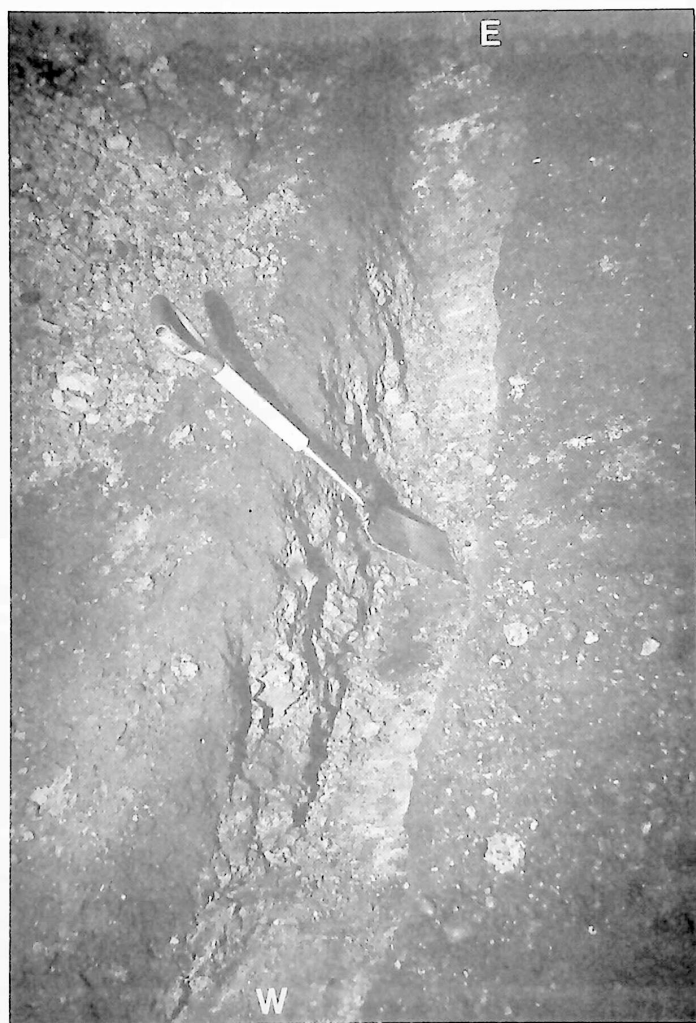
FIG:8 Undisturbed brick invert at ch.230 — 10 June 1974

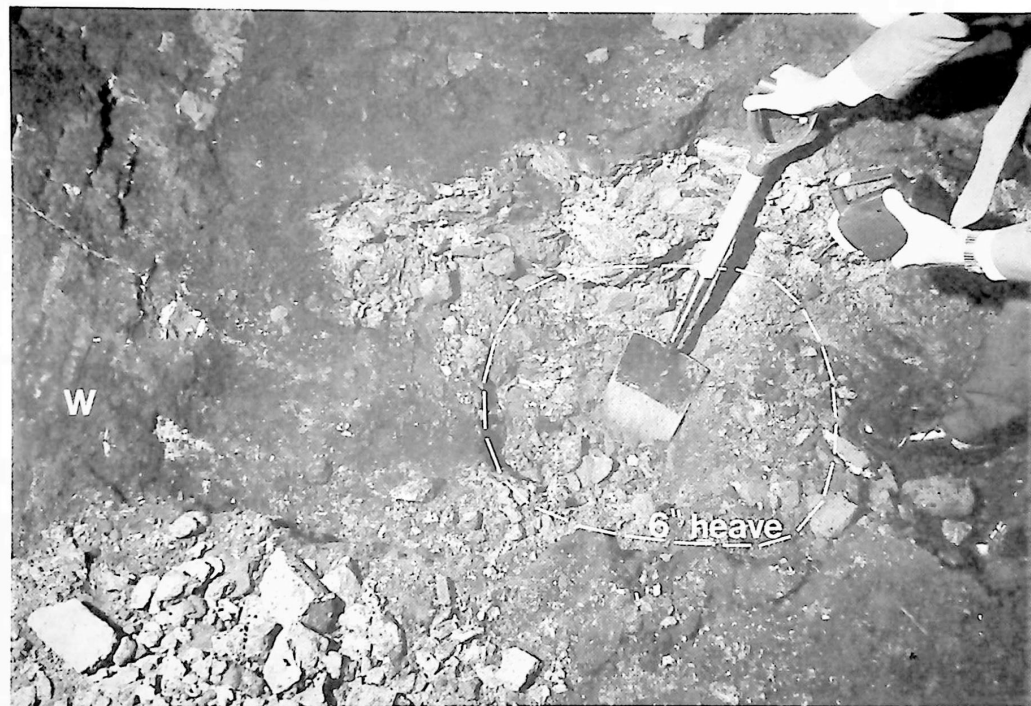
FIG:9. At ch.248 the brickwork had heaved west of centre by 6"—10 June 1974

You will see that at 230m the bottom brickwork is in perfect condition; at 248 the brickwork shows a hump at invert (not particularly visible now due to the cutting of the trial hole through the brickwork) and at 256m the bottom section of brickwork has sheared and tilted.

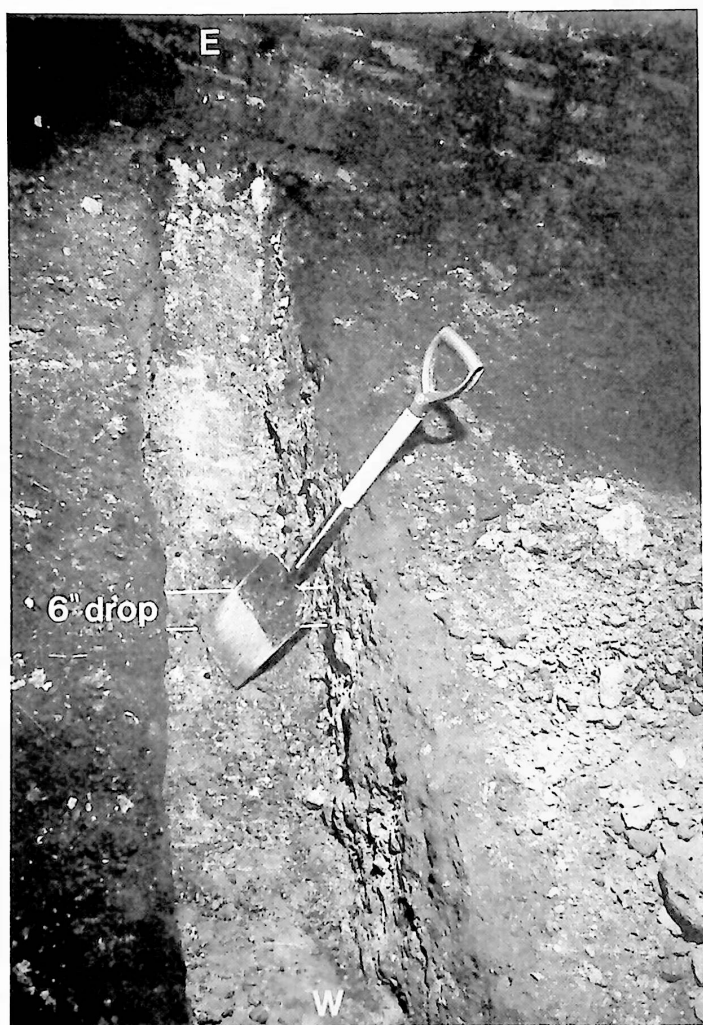
FIG:10. At ch. 256 showing the brickwork had sheared through over 6ft width and tilted by dropping 6" on the east side and rising 12" on the west-10 June 1974.

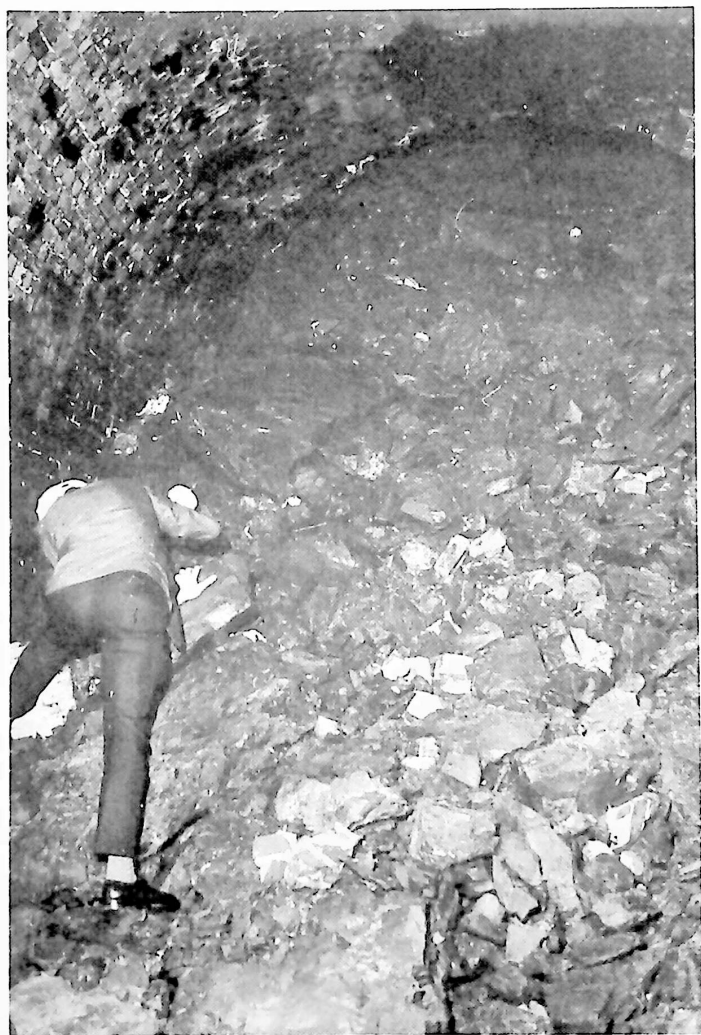
FIG:11. Ingress of clay at breach, ch 243 looking south,
9 July 1974.

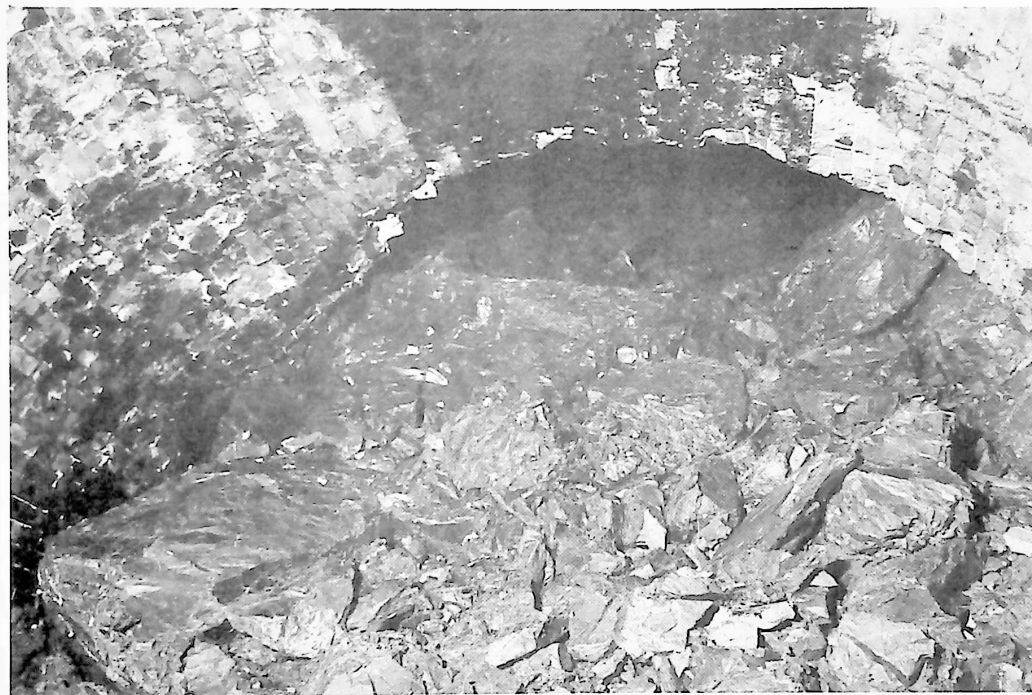
FIG:12 Cavity above clay fall at breach.ch 243 app.—9 July 1974

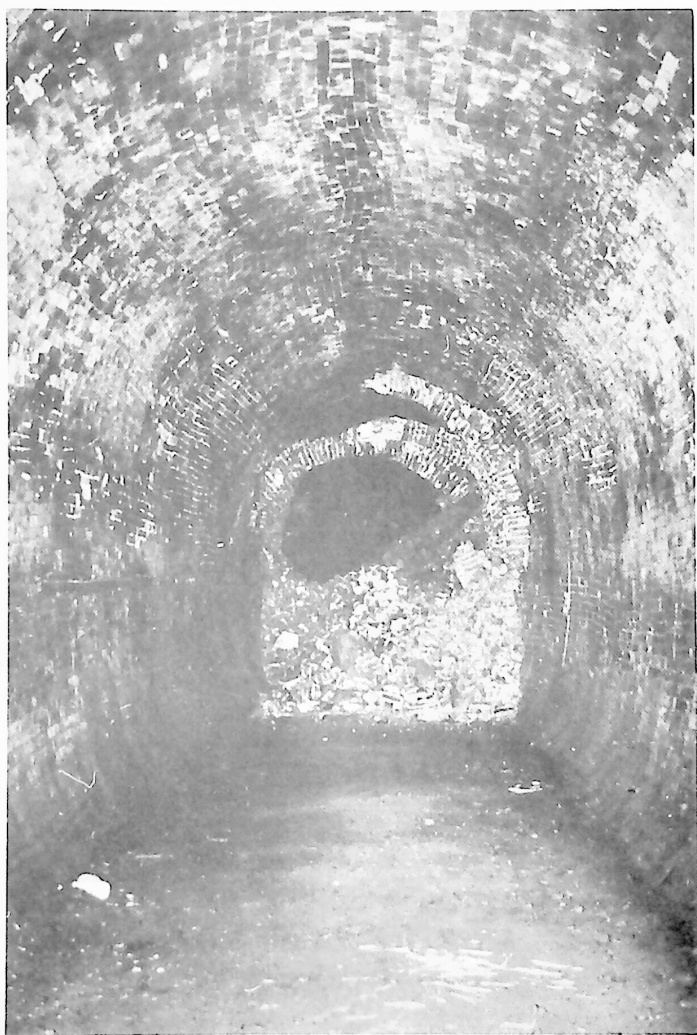
FIG:13. Showing falls at the second breach from about ch 263 to 266 (note fall at first breach ch 243 in background).—11 July 1974.

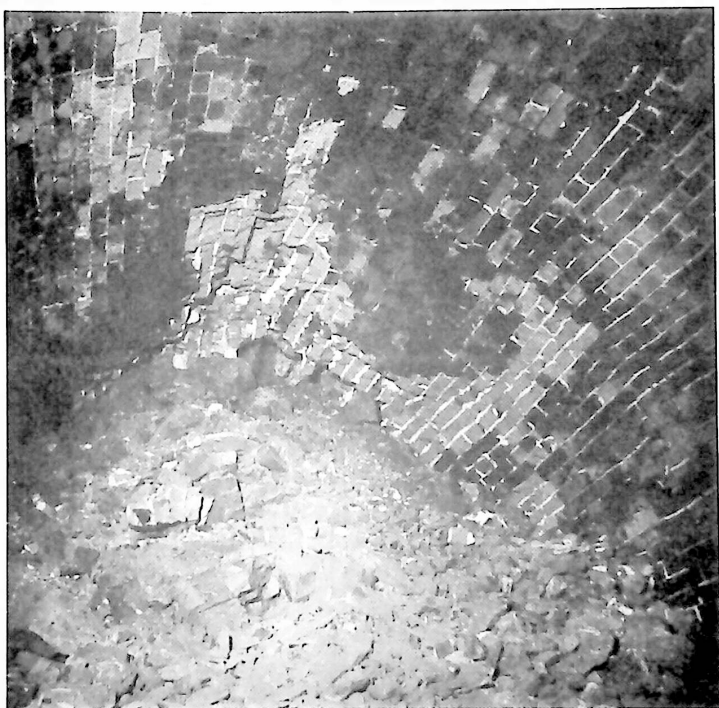
FIG:14. Showing top of fall at second breach at
about ch. 266 - 7. — 21 July 1974

For obvious reasons of safety events in the tunnel were not monitored after the subsidence. However, Figure 14 shows the top of the southern fall, as photographed on 21st July. The fall completely blocked the tunnel and reached almost to Chainage 270. Evidence from the site investigation and the remedial grouting indicates that the tunnel between the two observed falls did not remain intact and it is most probable that the arch collapsed over most of the length from Chainage 243 to 269.

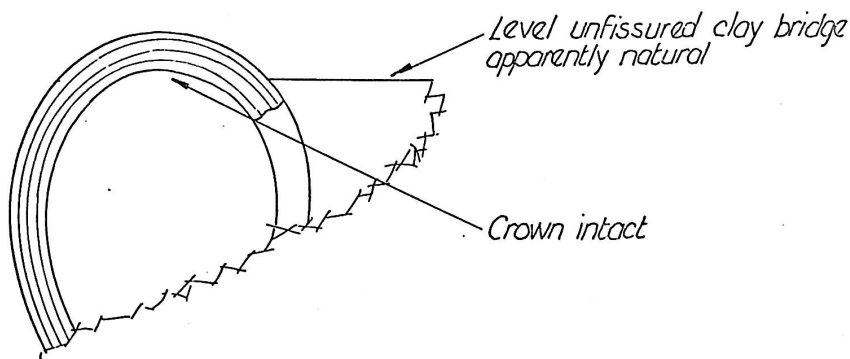
FIG. 16

I am enclosing a rather poor sketch (Report Note: Figure 16) of a section of the north breach as it was when I first saw it. I stood on the debris in the tunnel, which at that time had not extended completely across the tunnel floor and carefully examined the cavern which could be seen through the breach. I was particularly interested in the quite level and practically smooth bridge over the cavern which was about 8ft in

width and length along the length of the tunnel. The underside of the clay looked completely undisturbed and natural.

CAVITY TO WEST SIDE OF BREACH AT CH.243 ON 3RD JULY 1974
(From sketch by the University Surveyor and Deputy Registrar)

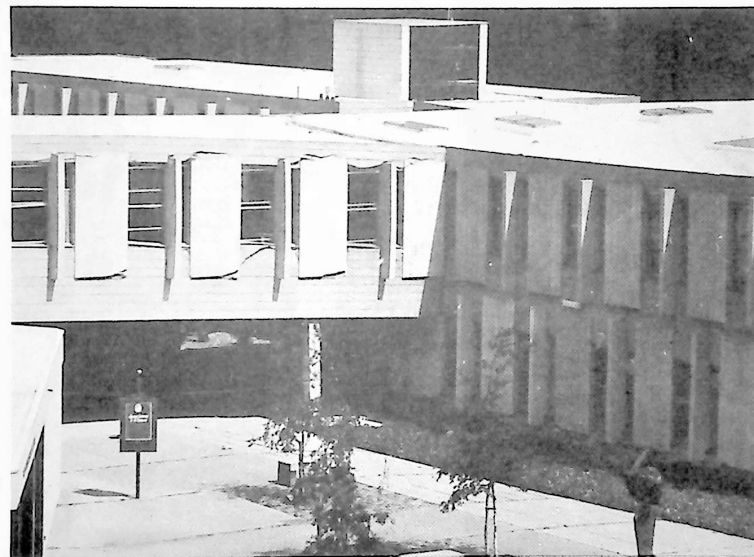
The link bridge suffered major damage from two causes. First the supports settled differentially giving rise to a considerable rotation of the structure, and second, largely as a result of this rotation, the upper floor of Block B remained connected to the end of the bridge even after its foundations had dropped away. This caused additional damage due to the extra load imposed on the cantilever end of the bridge. The damage is shown in Fig. 18, and Figures 19a & b show photographs of the foot of one of the link bridge columns and the west elevation of Block B from under the link bridge. An appreciation of the distortions described above can be gained from these pictures.

FIG:18. Damage to Block D

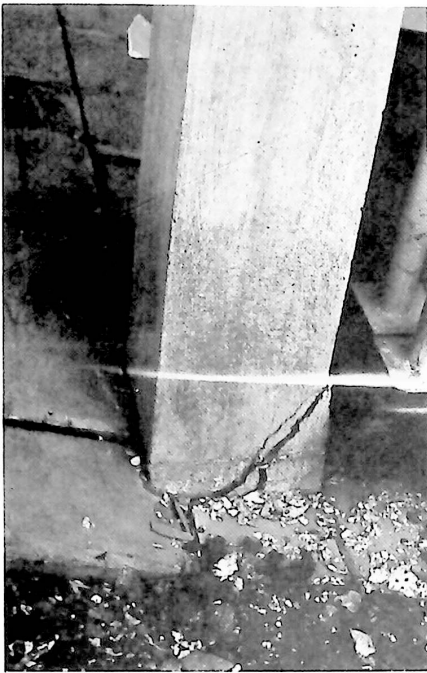
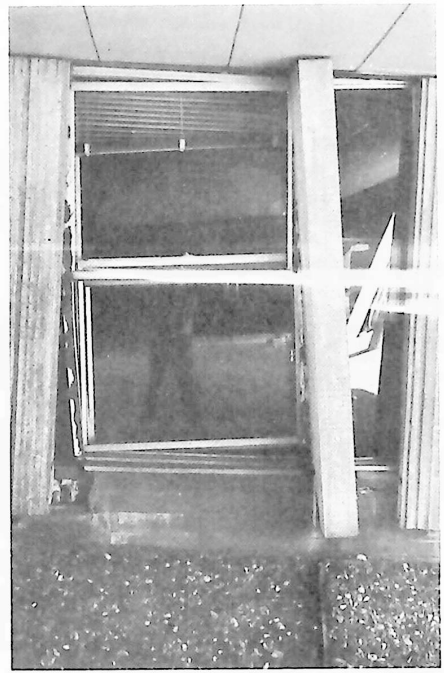
FIG:19. Details of damage to Cornwallis building.

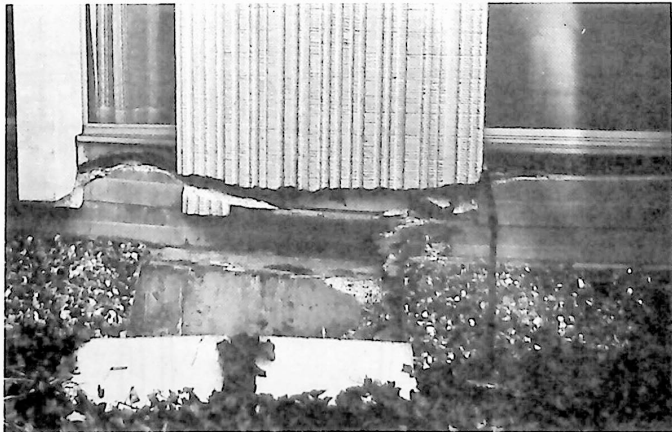
FIG:19(c)

The differential movements in Block B were of the order of 1 in 40 and the structure failed by breaking its back at a point 14.3m from its western end. The line of this failure can be seen in Figure 17 at the junction of the whole line and dashed portion of the plan which indicate the remaining and the demolished section of the building respectively. A curious feature of the damage to Block B was that at its western end, where the subsidence was maximum, the strip foundation which supported the perimeter of the block settled and dropped away from the load bearing panels it was intended to support. This tended to leave the first floor and roof supported by the internal columns and the cantilever end of the link bridge thus adding to the distortion on this latter structure.

This detail of the failure is shown in Figure 19(c) (It should be noted that the precast panels were designed as loadbearing supports to the structure above).

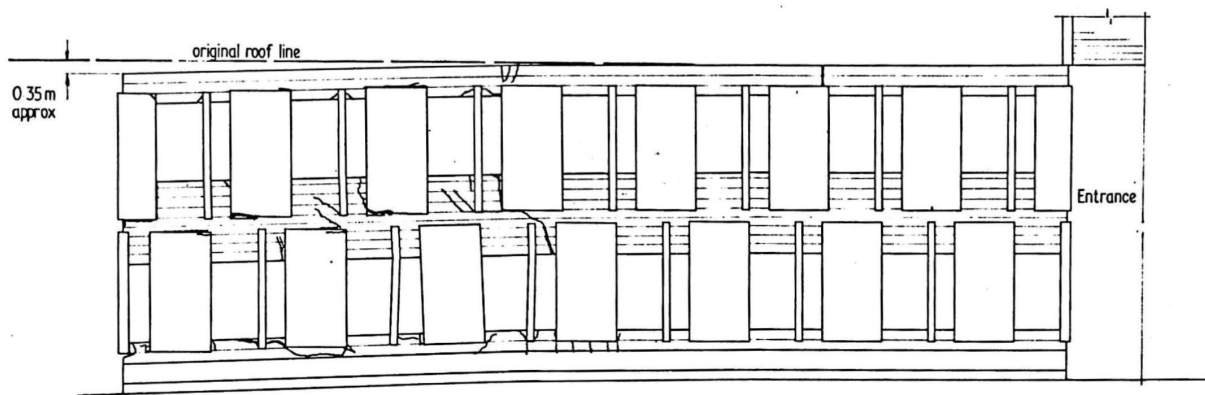
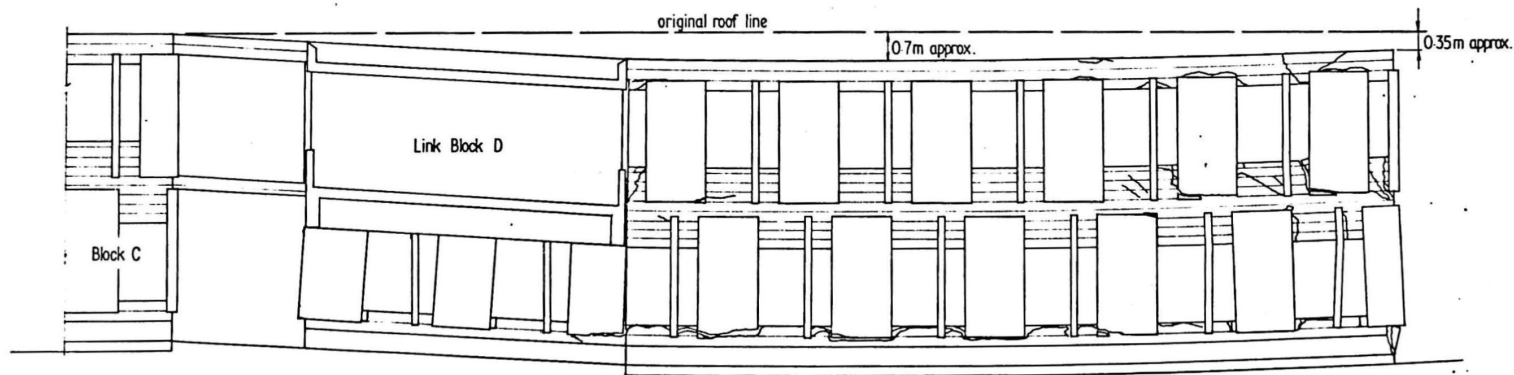
FIG.20

A detailed photographic survey of the damaged blocks was made and from this Figures 20, 21 & 22 have been produced which show the extent of the visible external damage.

VIEW 1-SOUTH EAST ELEVATION OF BLOCK B

VIEW 2-SOUTH WEST ELEVATION OF BLOCK B

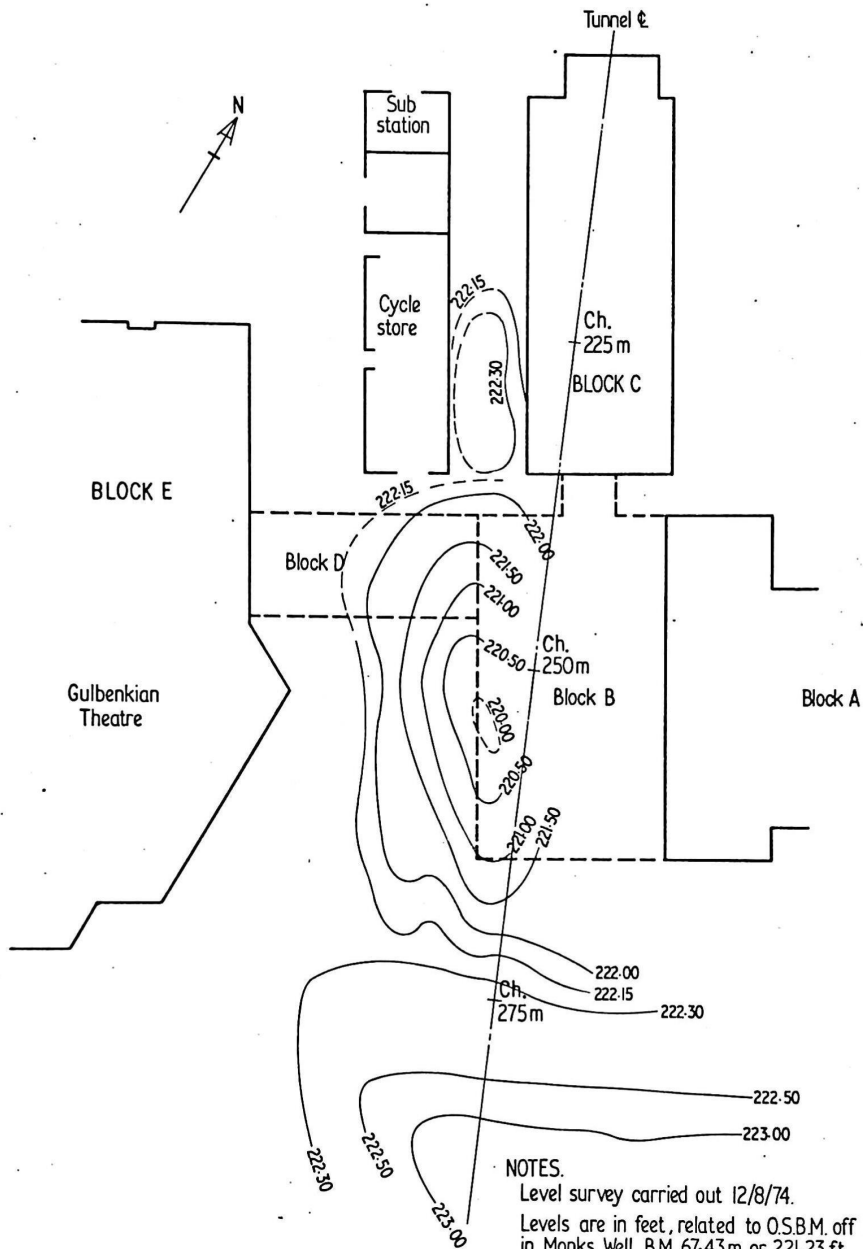
FIG. 23

The subsidence caused the ground surface to deform over an area of approximately 750m^2 in a bowl shape with a maximum settlement of 700mm. Only an approximate estimate of the extent of the surface depression has been possible since some fifty percent of it lay beneath the Cornwallis Block B. The ground contours shown in Figure 23 were measured on 12th August 1974 and from these the volume of the surface depression has been calculated as approximately 154m^3 . This can be compared with the original volume of the collapsed section of the tunnel which was approximately 348m^3 . This difference is considered in section 5.

Contoured plan of subsided ground

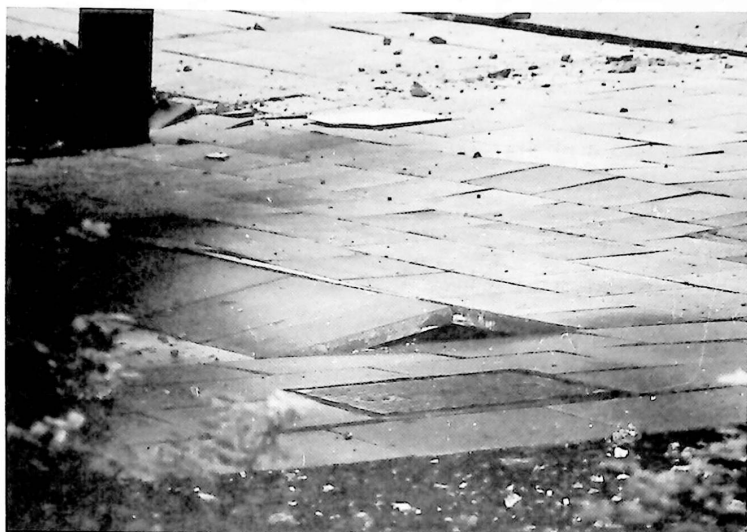
Figure 24 shows photographs of the paving slabs inside the depressed area. Figure 24(a) shows the slabs buckling in the compression zone at the centre of the area whereas Figure 24(b) shows a tensile zone at the edge of the depression where the slabs have parted by as much as four inches.

FIG:24 A. Compression of surface

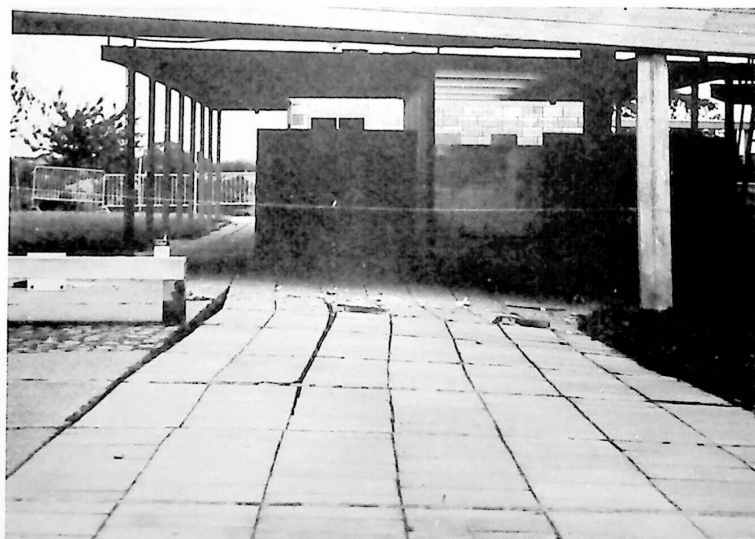
FIG: 24 B. Tension in surface

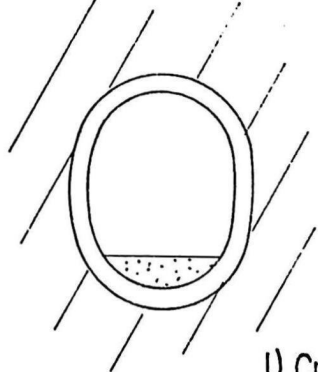
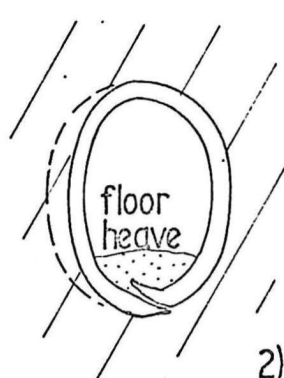
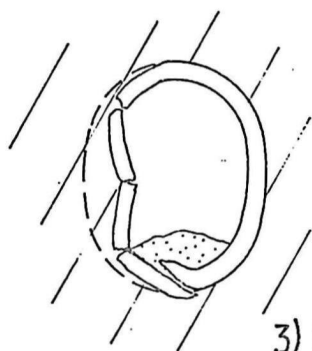
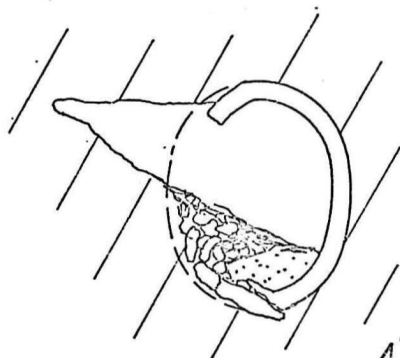
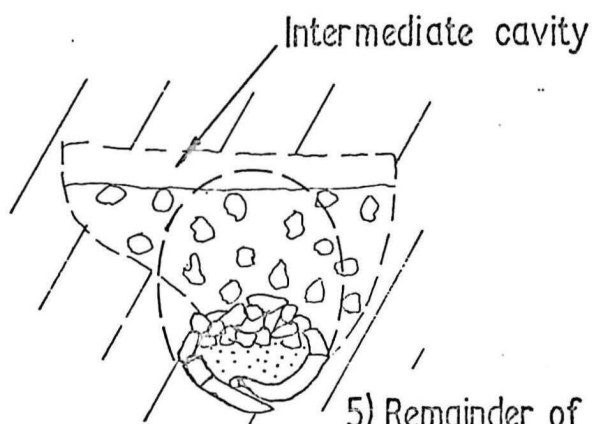
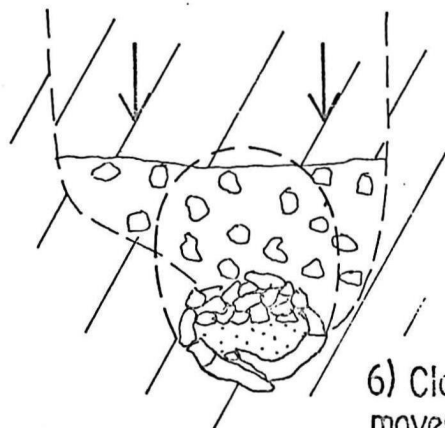
FIG.32

First the invert failed and this resulted in the removal of the effective haunch to the side wall arches of the tunnel. These then deformed under the load of the clay behind and finally failed in bending. This led to the ingress of clay into the tunnel and the formation of cavities which precipitated the subsidence in the manner described in 5.1.2 above. This sequence is illustrated in Figure 32.

Possible collapse mechanism
