UNIVERSITY of KENT at CANTERBURY

**REPORT
on
SUBSIDENCE**

JUNE 1975

HARRIS & SUTHERLAND,
Consulting Civil Engineers,
38-42 Whitfield Street,
London W1P 5RF.

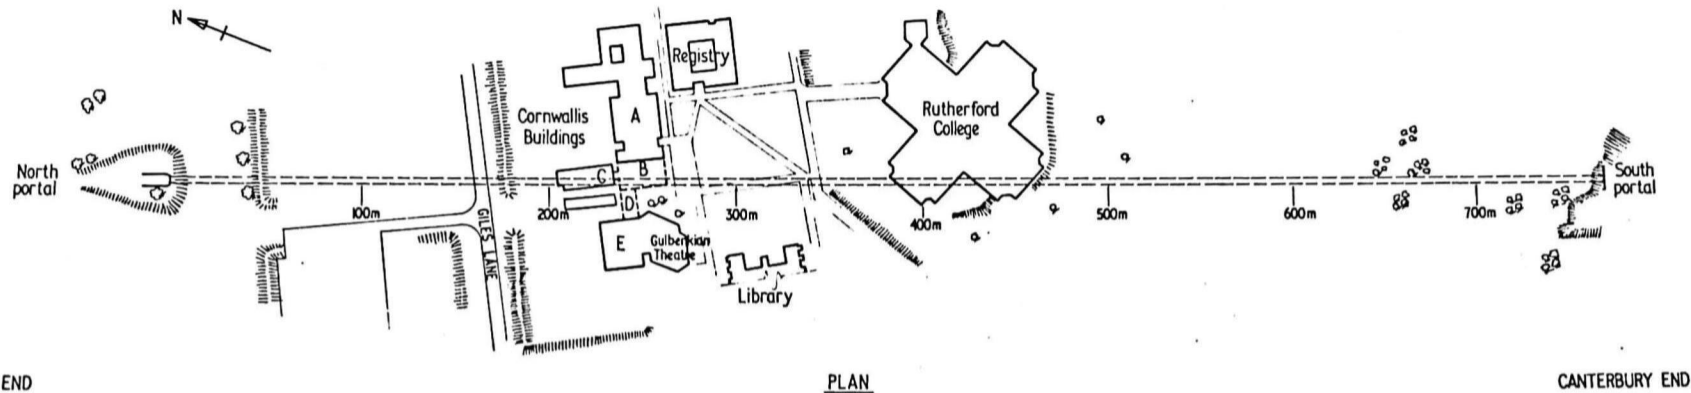
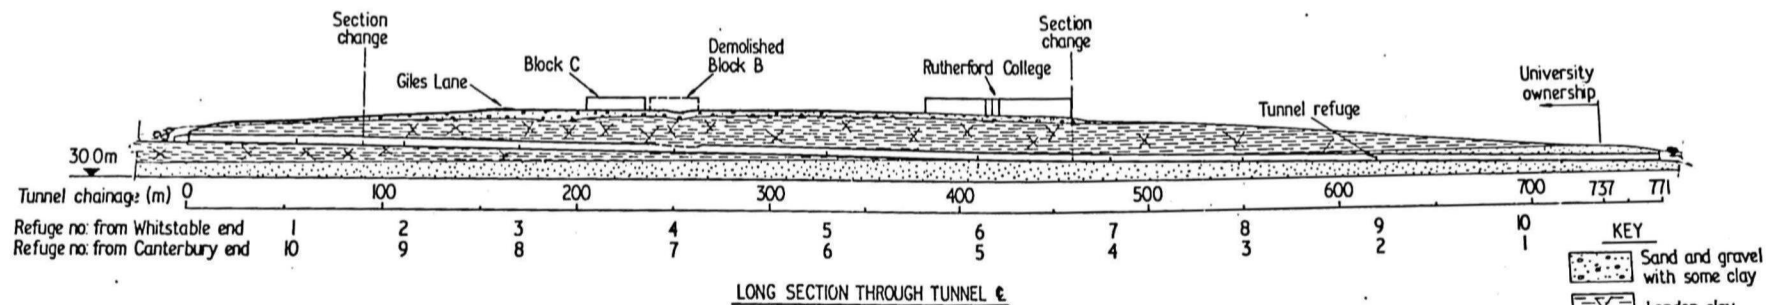
UNIVERSITY OF KENT AT CANTERBURY
FIG. 1
Plan and section of University campus

TUNNEL CROSS SECTIONS.

Blocks B and C of the Cornwallis building and Rutherford College are built over a disused tunnel on the former Canterbury to Whitstable railway line (see Fig. 1). This tunnel was built in 1827 and had been sold by British Railways to the University of Kent in 1963. The brick lining had been disintegrating over two short lengths below the Cornwallis building for several weeks prior to the major subsidence leading to a series of breaches with the ingress of clay on 3rd and 11th July. At the same time the Cornwallis building had been showing serious signs of distress, culminating in the subsidence.

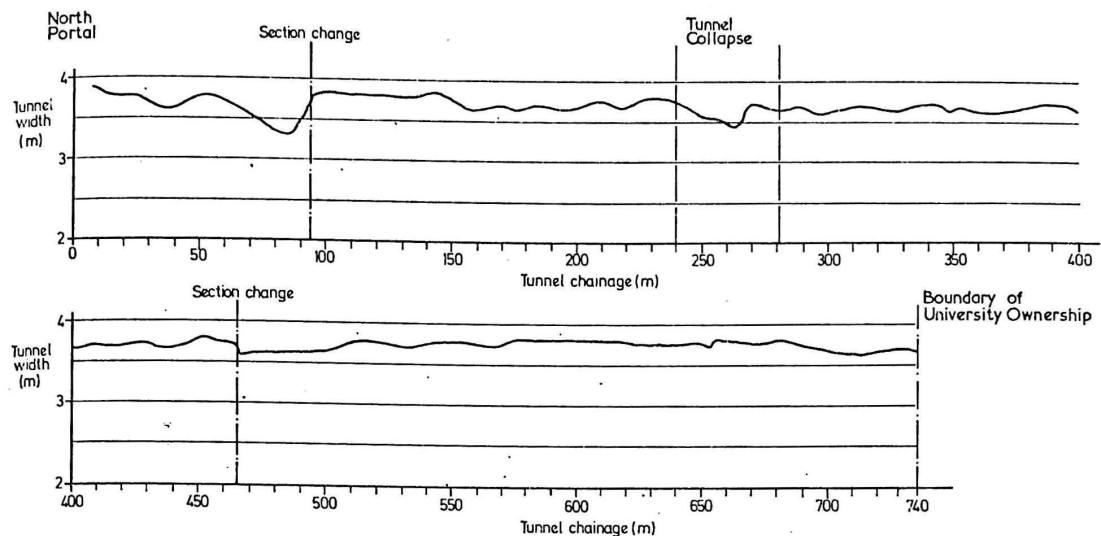
FIG:2 A
Variation in tunnel width.

The values are taken from the Farmer & Dark report of NOV.1973.

The width of the tunnel as recorded in the Farmer and Dark report showed considerable variation throughout its length. This is illustrated on Fig. 2A.

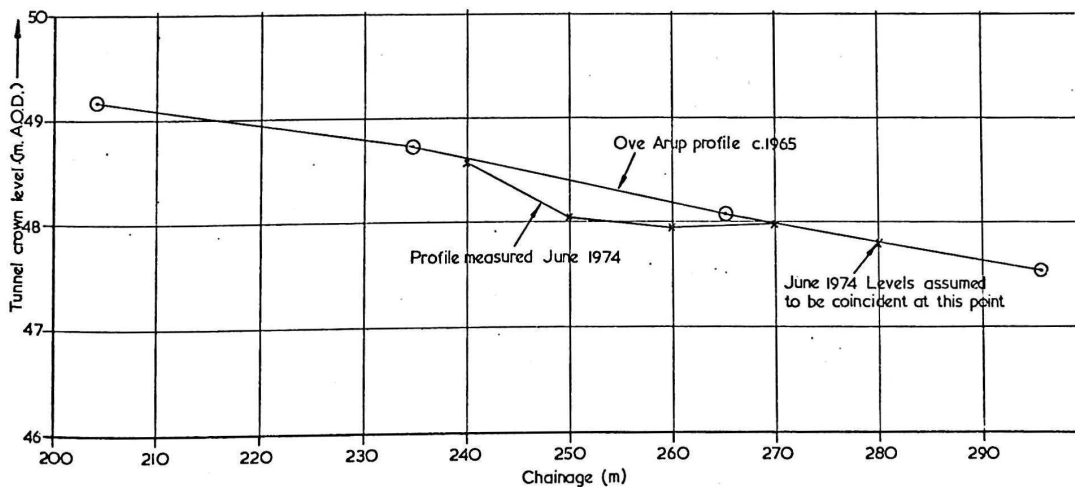
FIG:2B
Tunnel crown profiles

From the Maunsell report, the height of the tunnel, between the crown and the top of the invert fill material, varied along its length from that measured at the south portal of 3.86m to that at the north portal of 4.1m. The variation of the crown level over the failure zone is illustrated on Fig. 2B. This is based upon reduced levels taken during the Arup survey and relative levels taken by the University in June 1974.

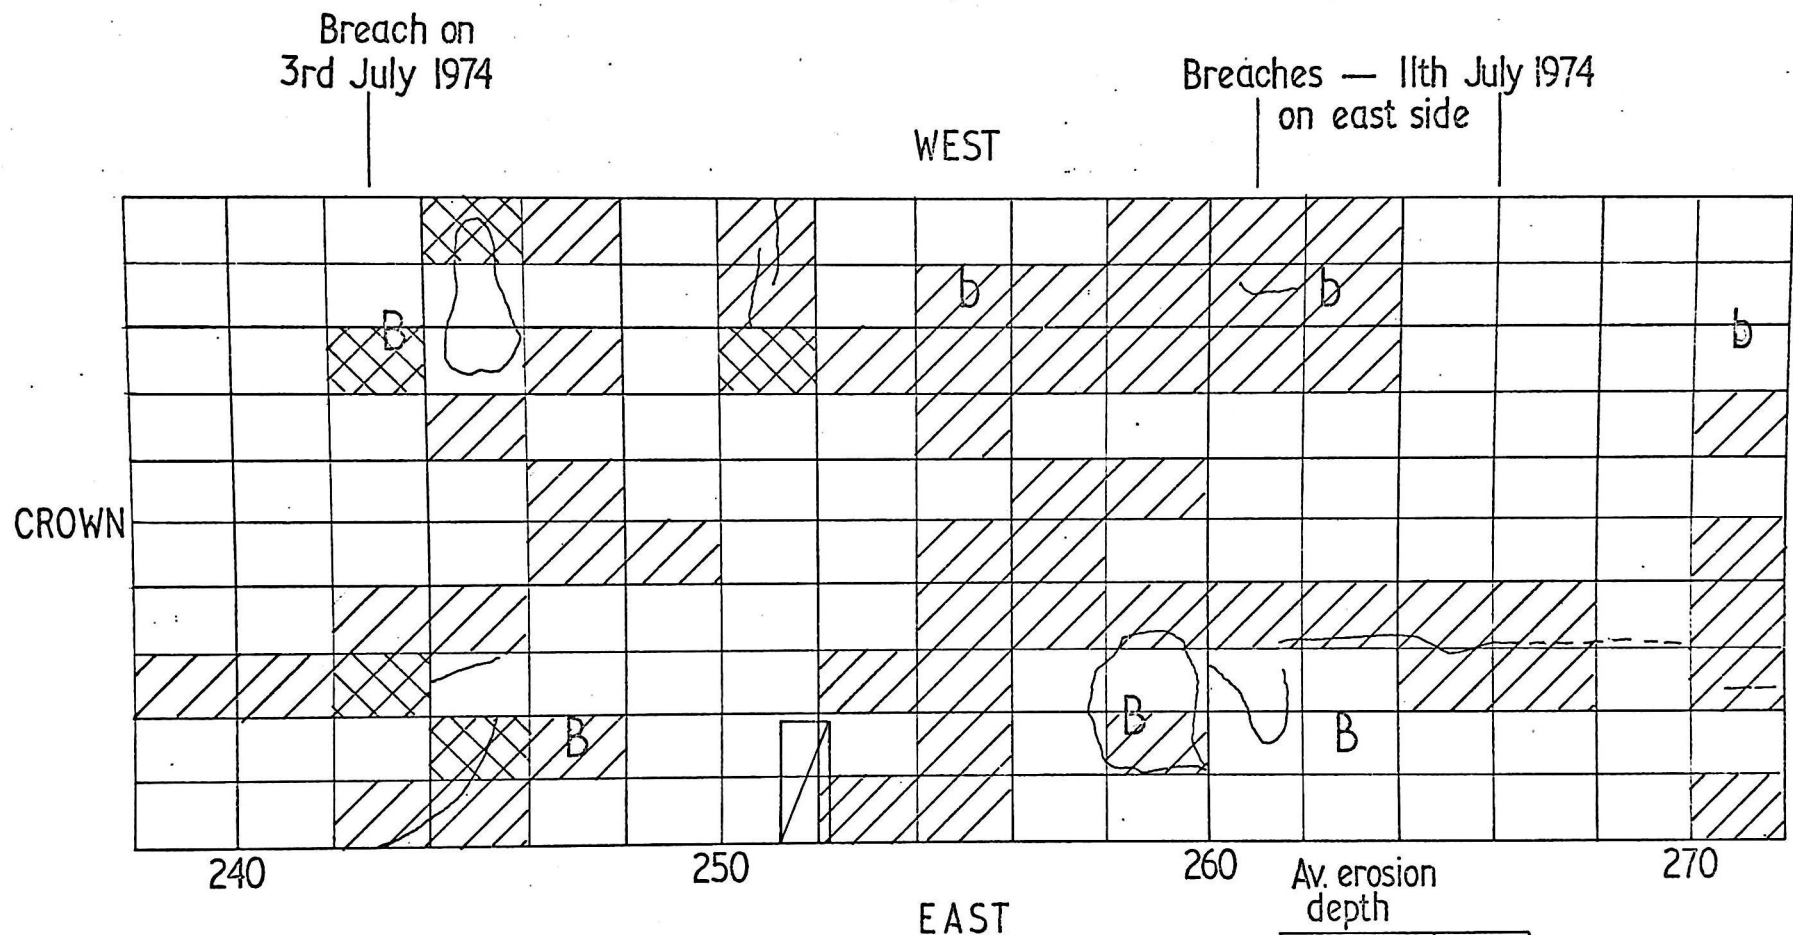
FIG. 4
1973 Farmer and Dark report.

10 mm		Inspect in 3 years
40 mm		
80 mm		Repair advisable
		Brwk 'drummy'

F & D report lining particularly bad at about Ch. 240-250. Worst place 2 half brick rings had failed.

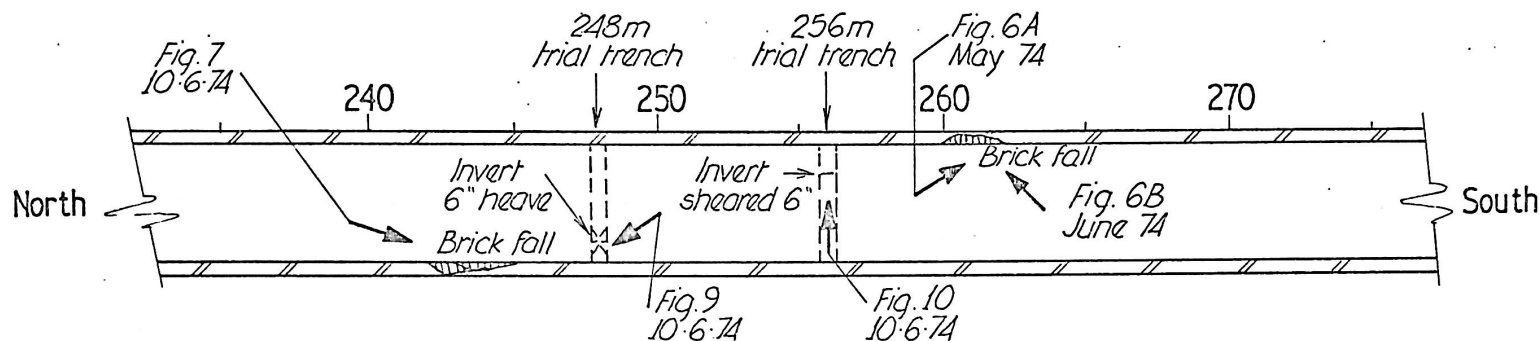
FIG: 15 A. Brick falls during May- June 1974.

At Ch. 240 brick spalling over about 6 sq.m mainly $\frac{1}{2}$ brick but deeper in places.

At Ch. 260 brick spalling over about 20 sq.m.

Scaffolding placed to stabilise peeling brickwork. Trenches reveal invert failure at Ch. 248 and 256.

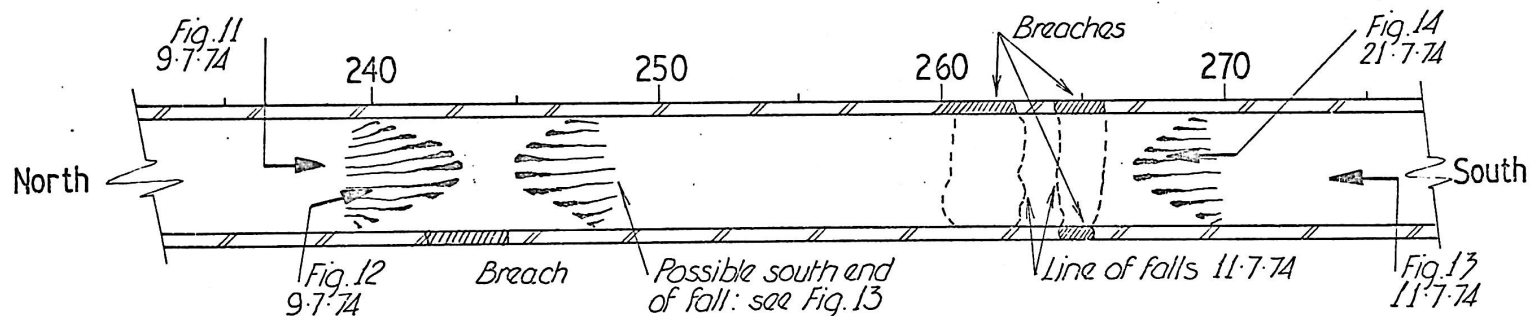
FIG: 15 B. Clay falls 3rd-11th July 1974.

Invert failure at Chainage 248 and 256 in early June 1974

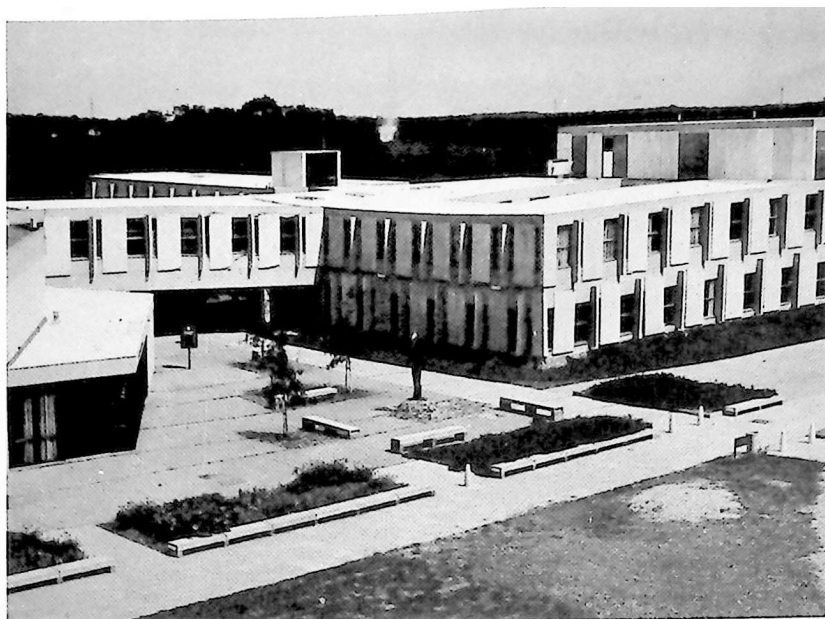
Cornwallis buildings photographed from Library roof.

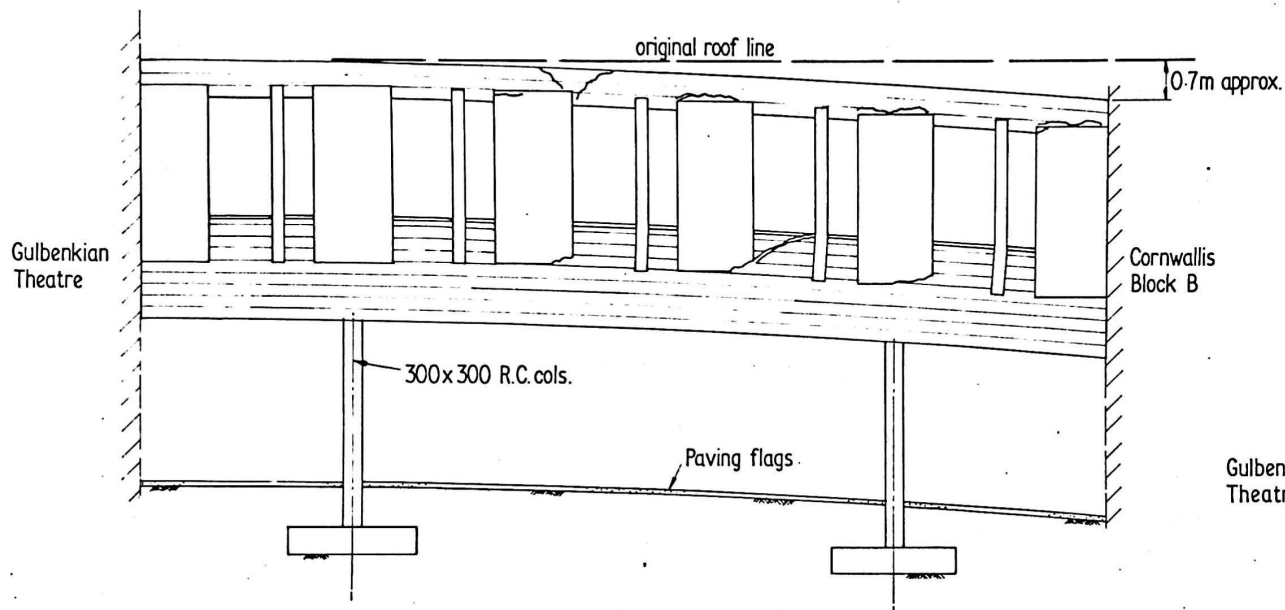
VIEW 3 SOUTH ELEVATION OF BLOCK D

A detailed photographic survey of the damaged blocks was made and from this Figures 20, 21 & 22 have been produced which show the extent of the visible external damage.

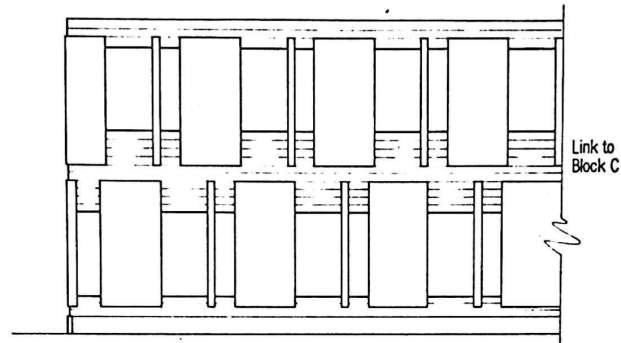
VIEW 4 — NORTH WEST ELEVATION OF BLOCK B

Block B had suffered severe damage and about 70 per cent of the structure was in danger of collapse (see Fig. 1). The link bridge and the damaged portion of Block B were also causing considerable distress to adjoining buildings on which they were now imposing large unexpected loads. There was therefore an urgent need to disconnect Blocks B and D from the adjoining buildings. At this stage it was impossible

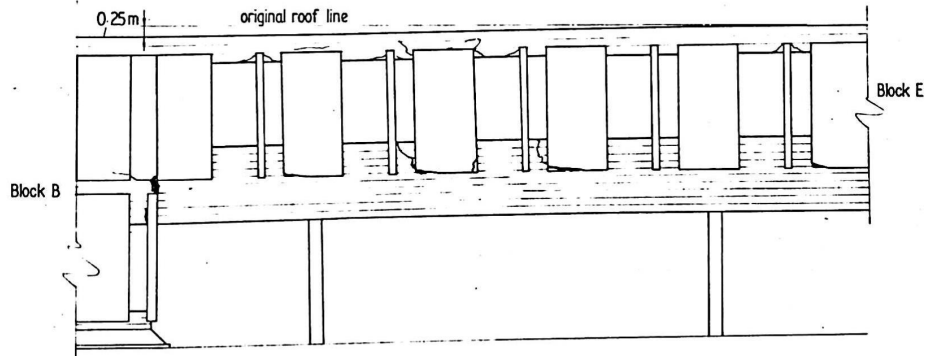
VIEW 5—NORTH WEST ELEVATION OF BLOCK D

Cracks noted in partition on 1st floor of Block D (Link). Level check to underside of floor reveals slight difference & SE column 5mm lower than NE column

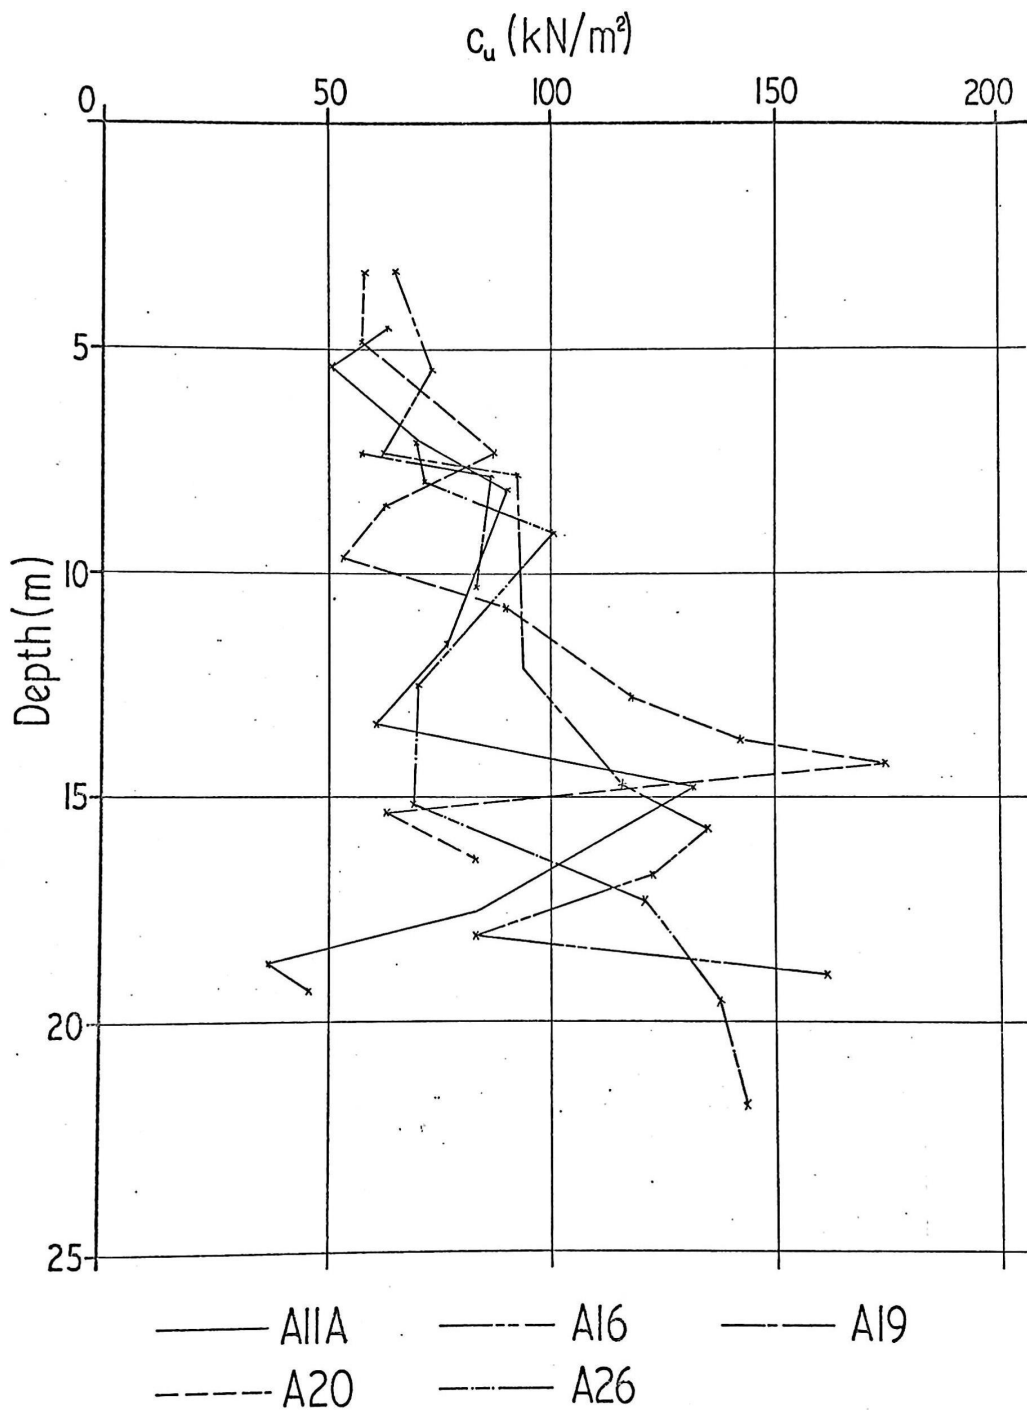
FIG. 27

Figure 27 shows graphs of the undrained shear strength with depth at several locations. It can be seen that in spite of the precautions taken there is a large scatter in the results. However, it is also clear that the strength of the clay samples from the zone of subsidence is not significantly different from that of those taken elsewhere.

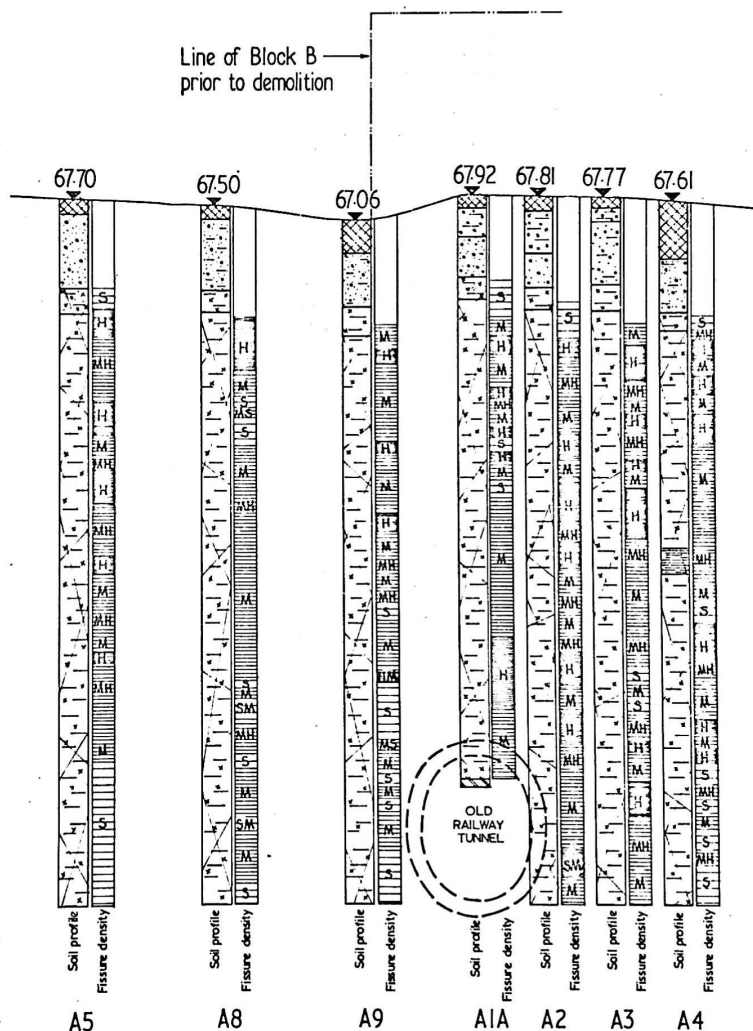
FIG. 28A

The complete results of the soils investigation are given in the Cementation Ground Engineering report No. 5088/74/JMJ, dated May 1975. A cross section through the subsidence zone is shown in Figures 28A & B. The information on these figures was taken from boreholes A1A, A2, A3, A4, A5, A6, A7, A8 and A9. It can be seen that the soil in this zone has been subject to considerable disturbance. However, there was no evidence found to suggest that the surface subsidence was caused by a cavity progressively caving in and rising to the surface and the majority of the samples inspected were intact. This leads to the conclusion, as discussed in section 5.1, that the soil probably failed as a single plug. There is evidence of disturbance and clay and brick rubble at the tunnel level and this is consistent with the clay rubble seen at each end of the collapsed section of the tunnel.

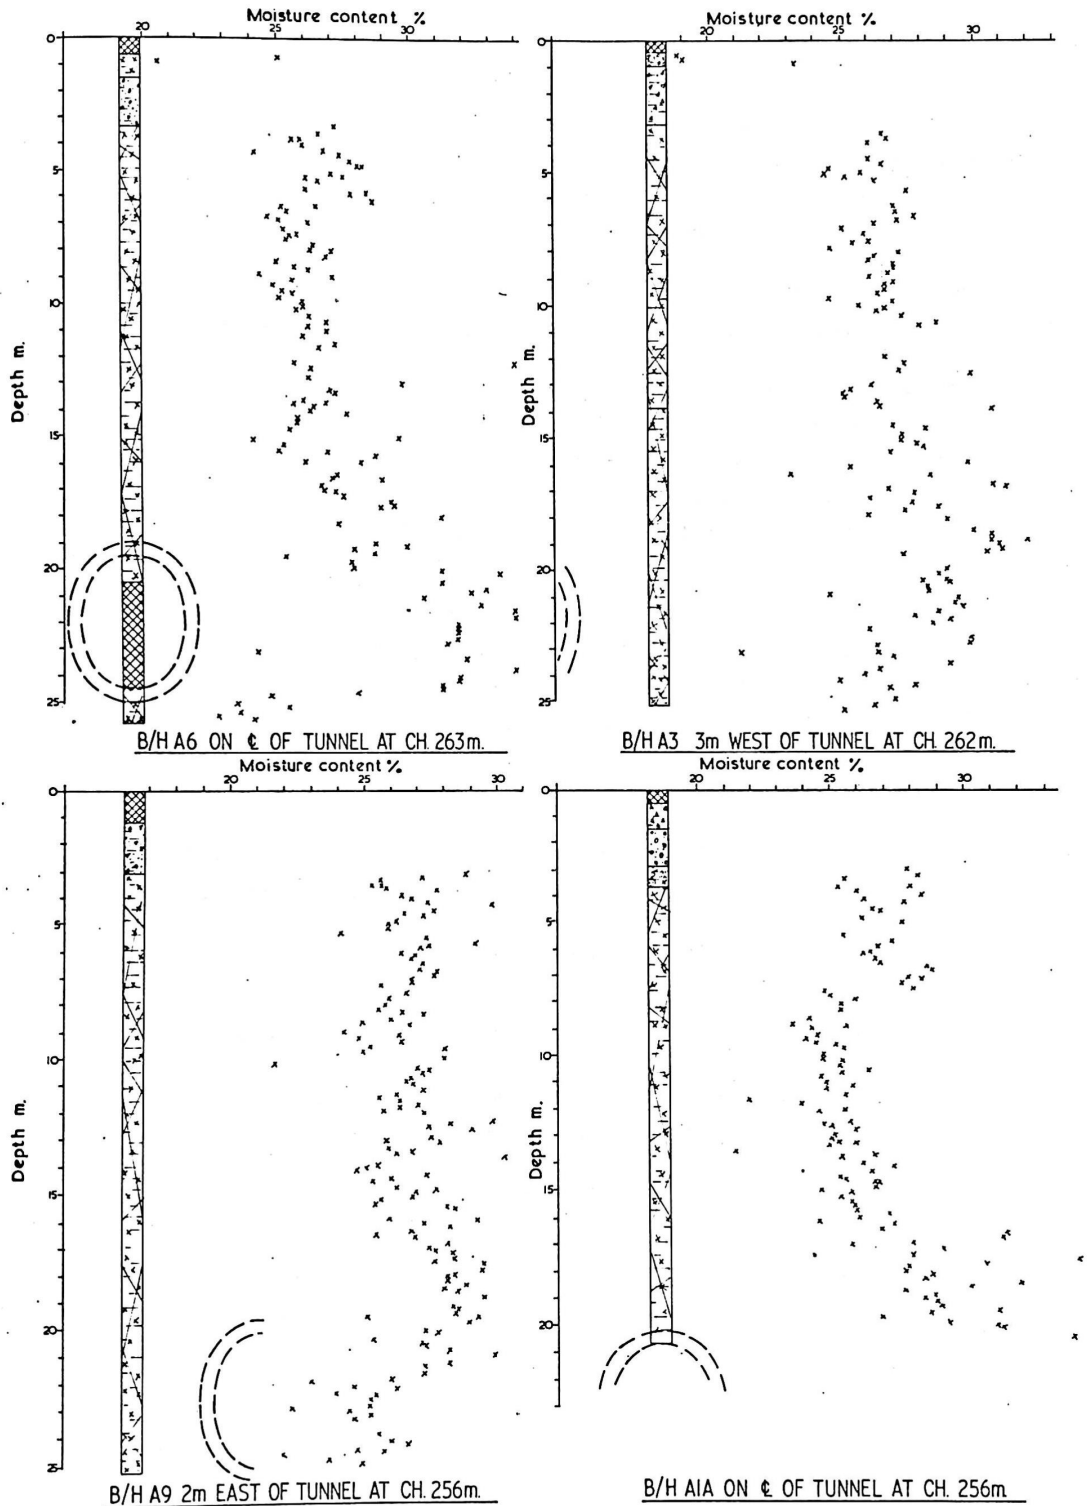
FIG.29

Figure 29 shows a plot of the moisture content/depth profiles for four boreholes in the collapsed zone. It will be seen that away from the tunnel the moisture content is roughly constant at about 25 - 27%

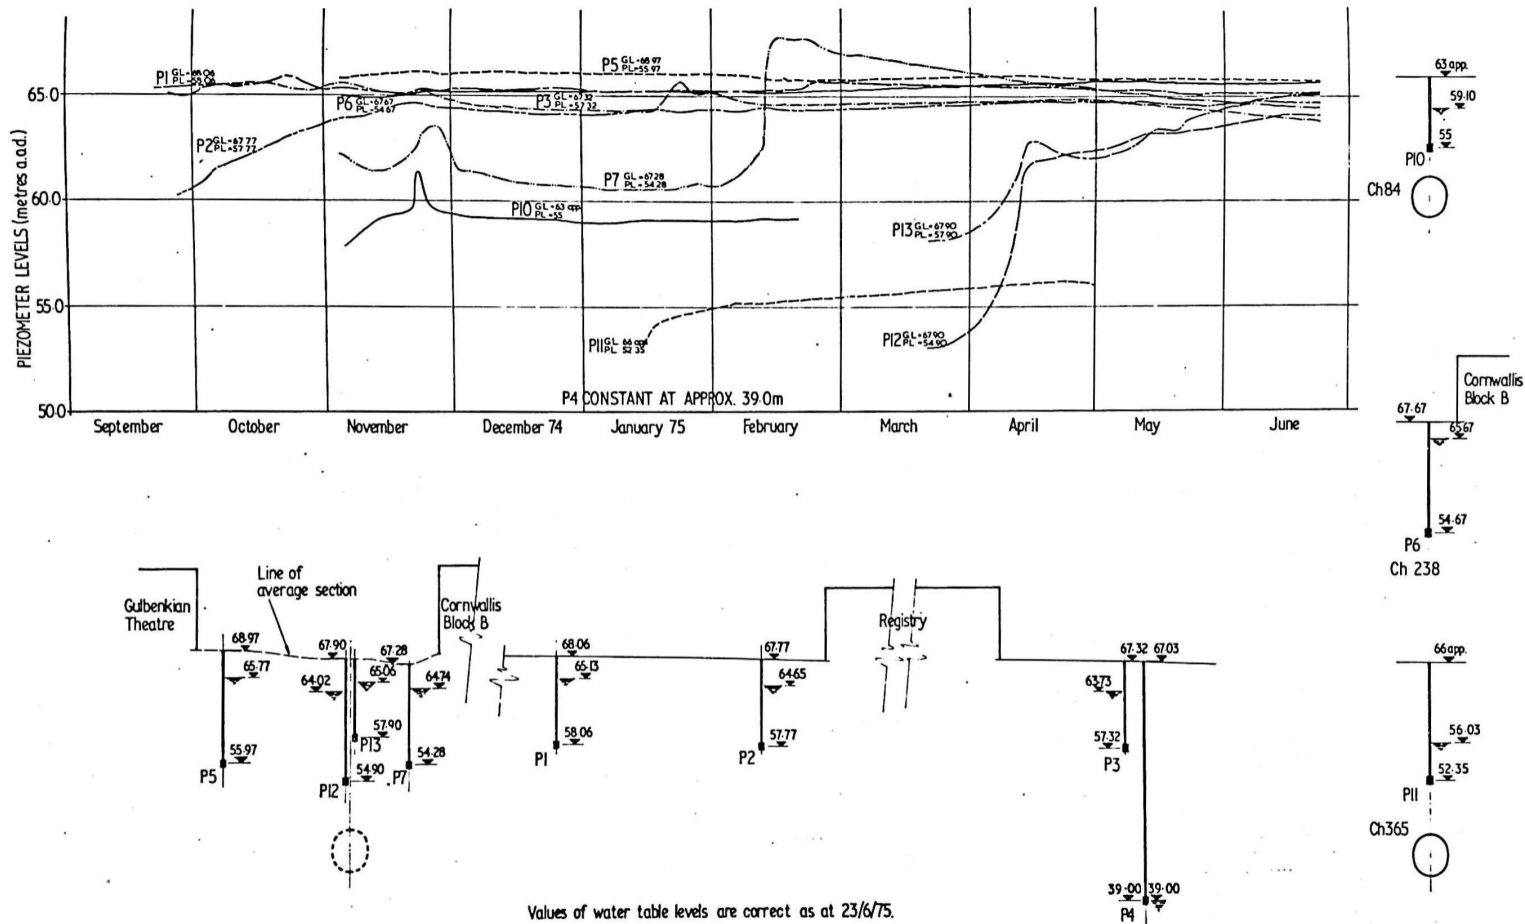
FIG. 30

The piezometer results are shown in Figure 30 where it can be seen that

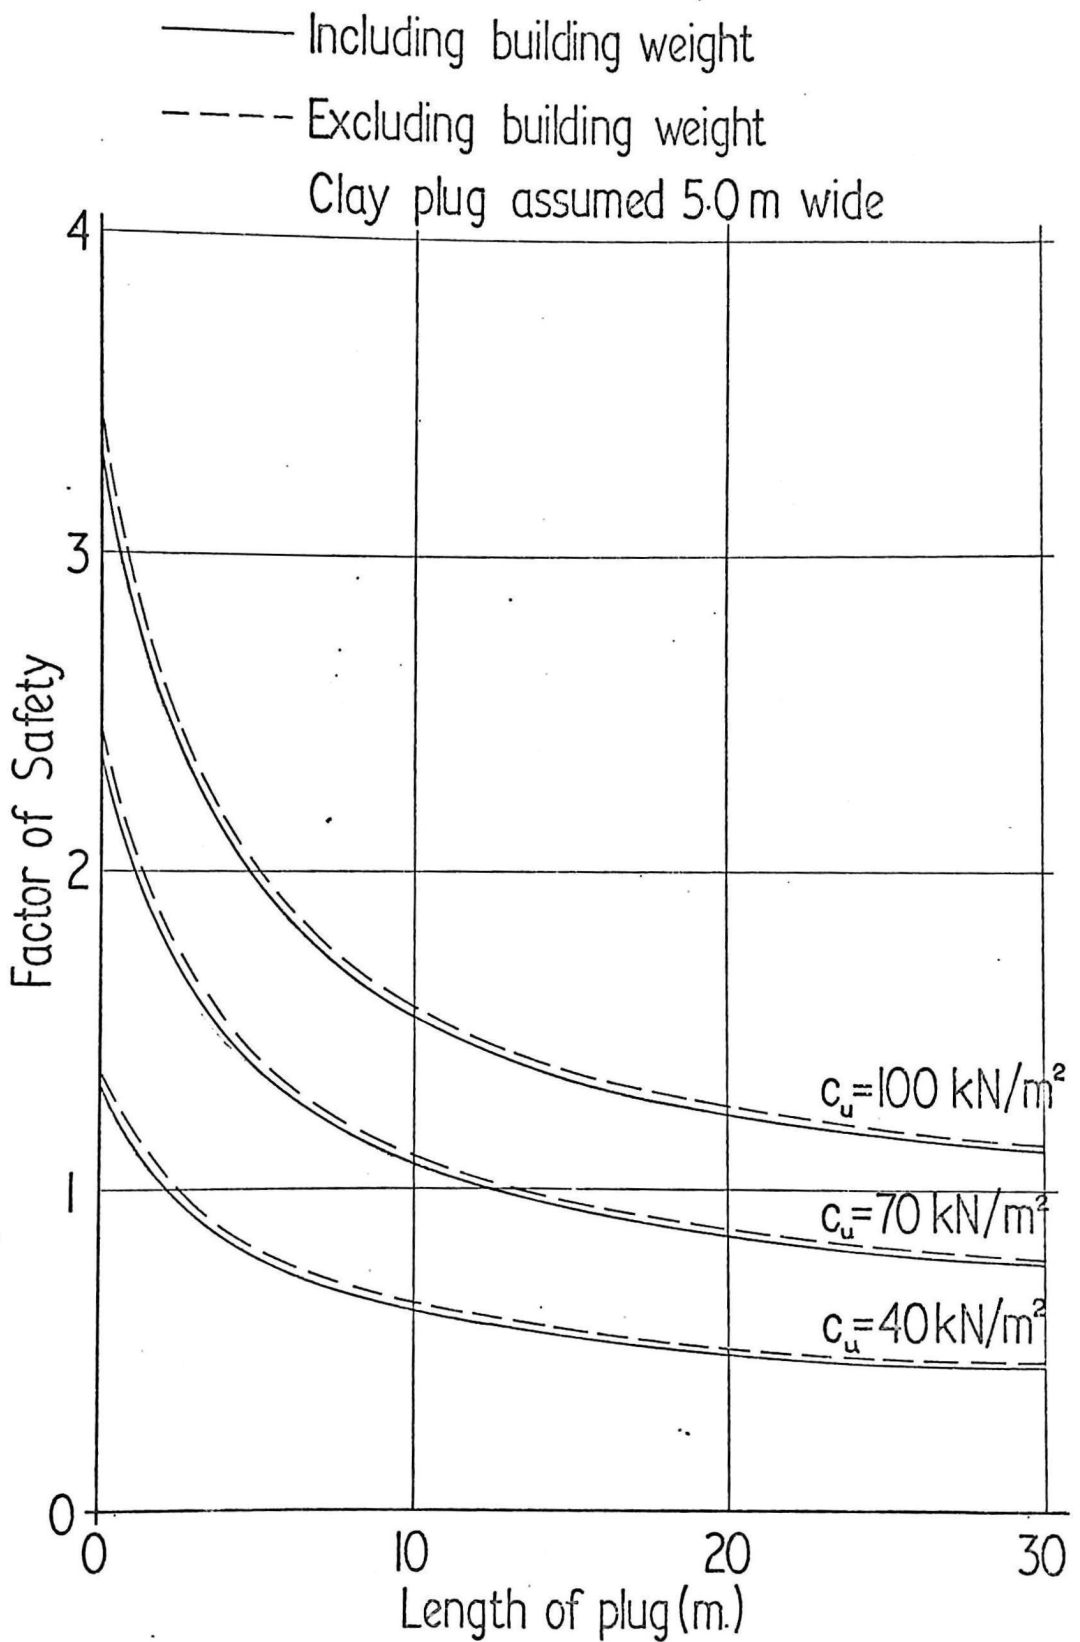
FIG:33

Figure 33 shows the factor of safety against failure in undrained shear for clay plugs of various lengths and values of shear strength. Also shown is the effect of a surcharge of 10 KN/m^2 (200 lbs/ft^2) which has been assumed to represent the approximate weight of the Cornwallis

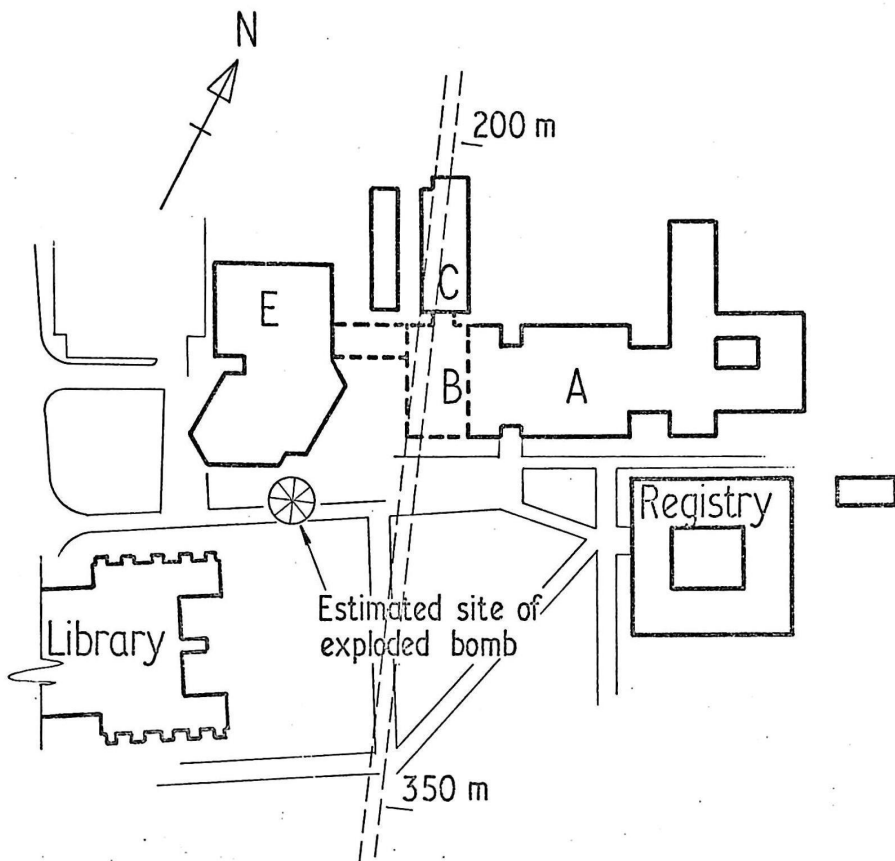
A copy of an aerial photograph of the site, taken in 1946, was carefully examined and this showed a discolouration of the ground surface at approximately the position indicated by the eye witnesses. When plotted as accurately as possible on a plan of the University site this mark falls at the position indicated on Figure 34. There is no absolute evidence that this discolouration of the ground surface was in fact the site of the bomb crater but in any event it is considered that at the location plotted it could not have had an effect on the tunnel more than thirty years after the explosion unless it had considerably weakened the ground and the tunnel lining at the time of the explosion. Other than some seepage of water reported at the time (information obtained verbally from a retired railways plate layer) there is no other evidence of this.

Exploded bomb site estimated from aerial photographs to be 21.5 ± 1 m. west of tunnel at 283.5 ± 2.5 m.

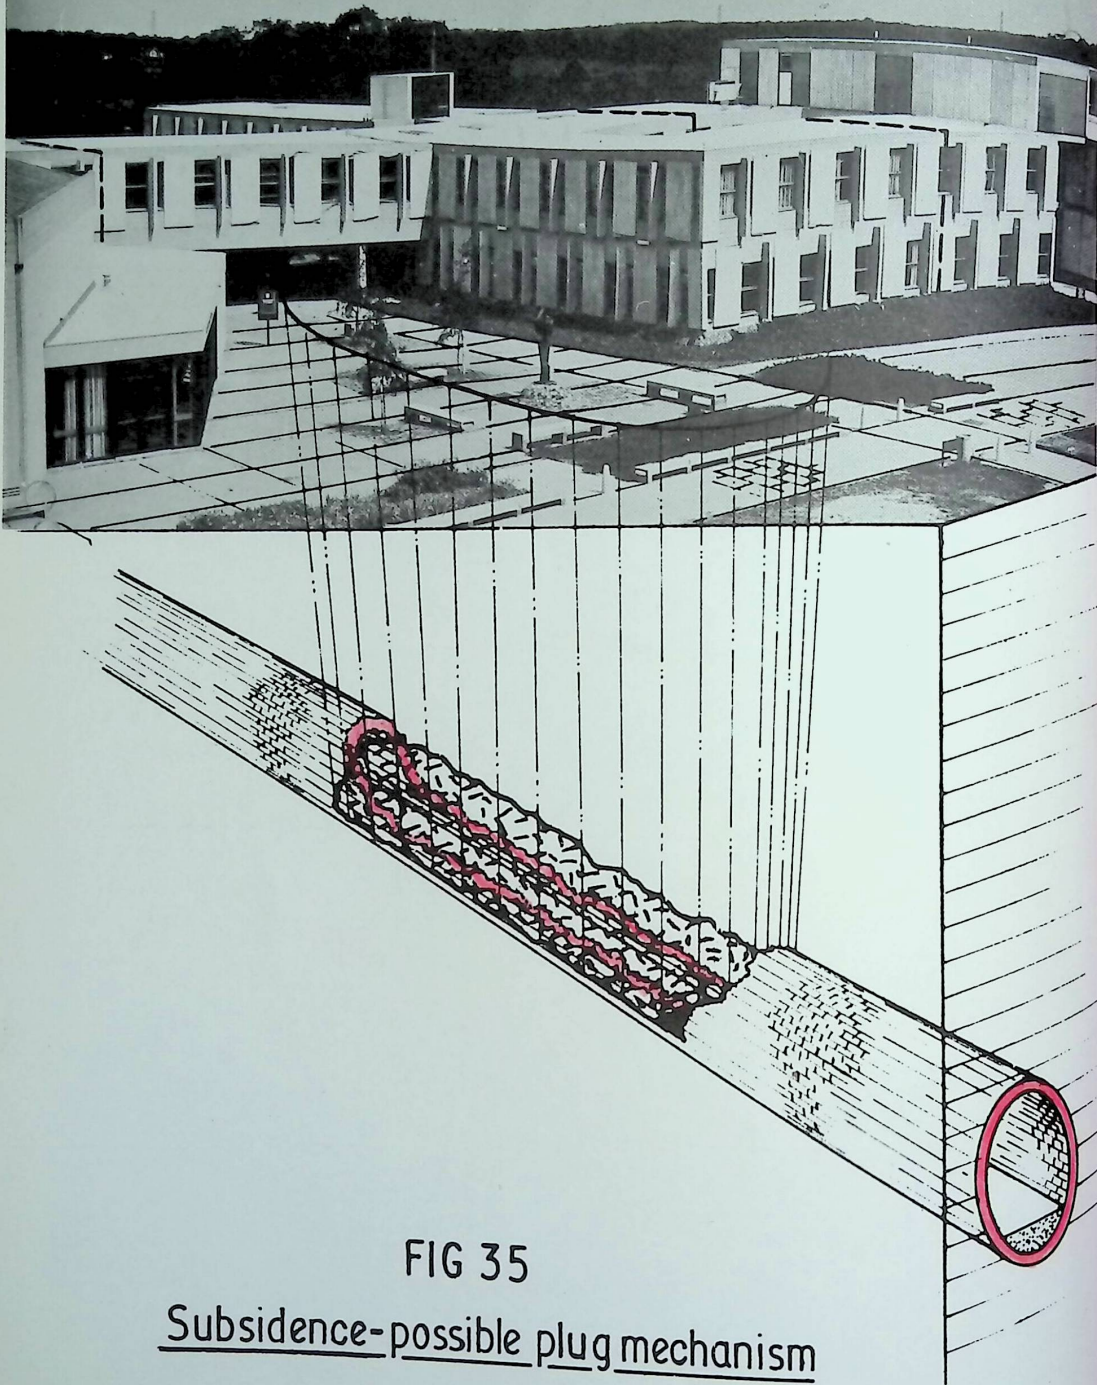
FIG 35

Clear evidence of the formation of a cavity is given by the Surveyor and Deputy Registrar in his eye witness account of the state of the breach at Chainage 243 on 3rd July 1974 (Illustrated by Figure 16) During the following days this breach increased in size with more and more clay falling into the tunnel until, by the 9th July, the tunnel was completely blocked (see Figure 11) Figure 12 suggests that this void still existed on 9th July since the clay had not bulked up completely to the roof. With the advent of further breaches in the lining at two locations within Chainages 260 to 268 and the consequent ingress of clay during the afternoon of 11th July, further cavities would have occurred. As they developed, probably uniting with the earlier cavity at Chainage 243, a critical condition was reached and the ground subsided as a plug on the evening of the same day. (Possibly as shown in Figure 35).

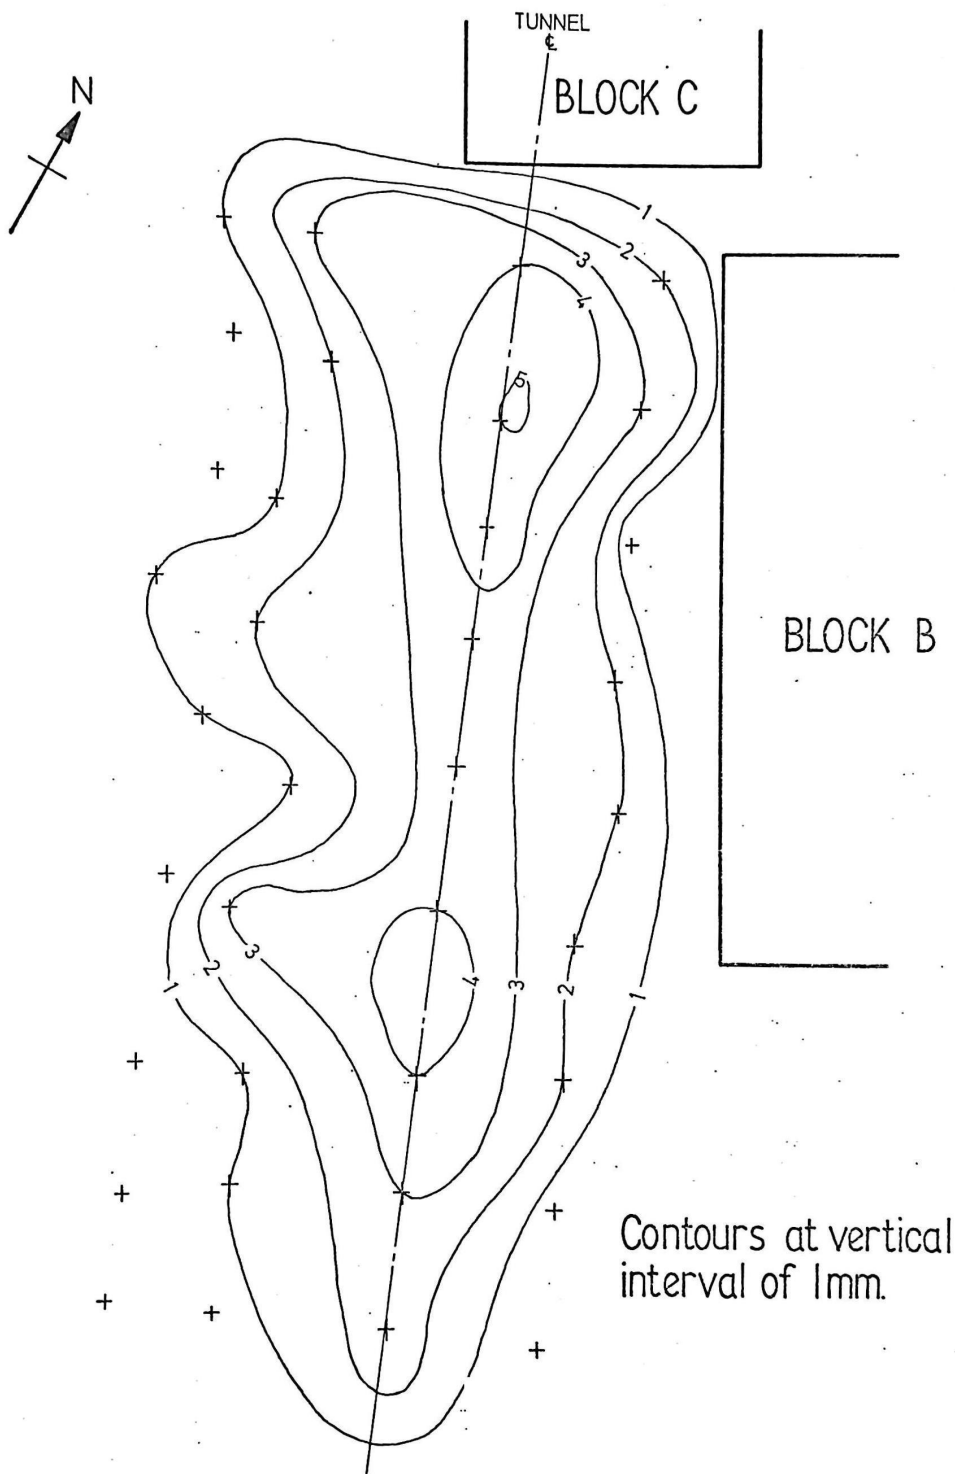
FIG: E2.
Sketch showing ground heave due to grouting.

However, this effect was used to indicate when the maximum induced horizontal stress had been achieved and the compaction grouting was curtailed when a single 0.1m^3 injection of grout at any point in the soil mass caused surface heave of approximately 1mm. Figure E2 shows the cumulative heave measured at the surface after the compaction grouting had been completed. Precise levelling techniques were used to monitor the whole grouting operation in order to avoid damage to the existing buildings which surround the subsidence area. To achieve this precise monitoring 36 short 2.0m long piles were installed on a grid over the whole site and measurements were taken at frequent intervals onto steel reinforcing bars set into the piles.
